Use Attainability Analysis

WBID 1314 Drywood Creek

Submitted by  
SES, Inc.

To  
Missouri Department of Natural Resources  
Water Protection Program

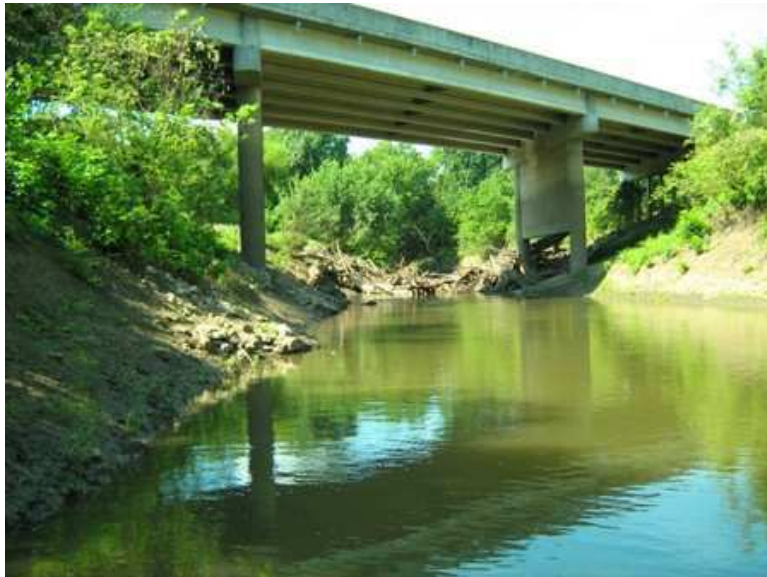
**Site# 1 Photo ID# 39, Upstream**

**WBID #** 1314      **Site #** 5.4  
**Mark #** 49      **Dissolved Oxygen (ppm)** 5.4  
**Upstream Views Physical Dimensions:** Is there any water present at this view? y  
 If so, is there an obvious current? n

% of Channel Feature				
Riffle					
Run	100				
Pool

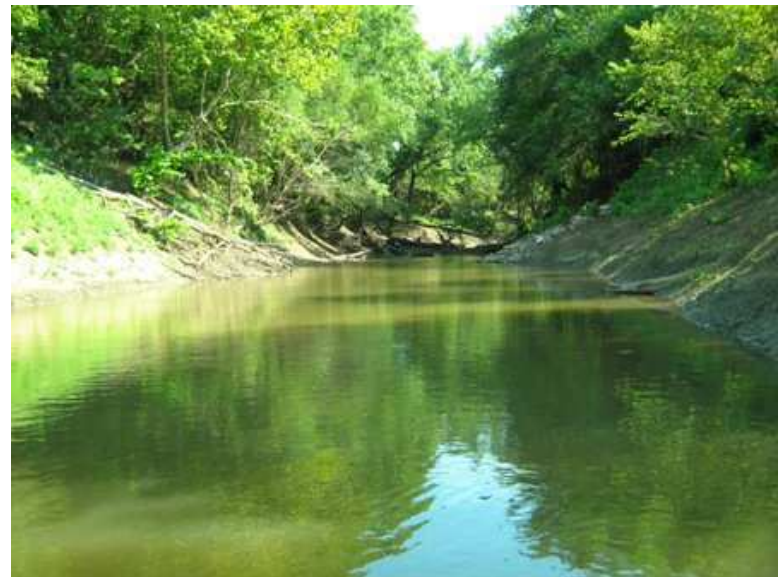
**Site# 1 Photo ID# 38, Downstream**

**Downstream View's Physical Dimensions:** Is there any water present at this view? y  
 If so, is there an obvious current? y

% Cobble	% Gravel	% Sand	50% Silt
50% Mud/Clay	% Bedrock

Odor	Sewage	Musky	Chemical	<u><b>None</b></u>	Other
Color	Clear	<u><b>Green</b></u>	Gray	Milky	Other
Bottom Deposit	Sludge	Solids	<u><b>Fine Sed.</b></u>	None	Other
Surface Deposit	Oil	Scum	Foam	<u><b>None</b></u>	Other

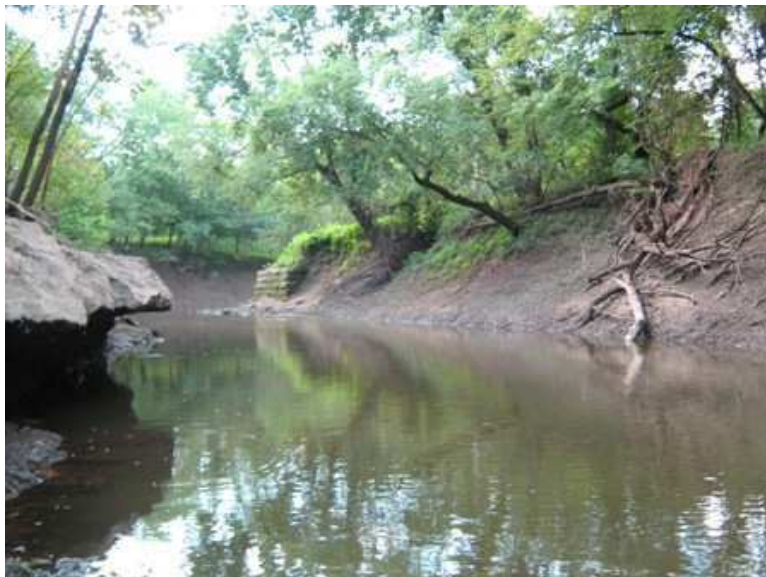
**Site# 2 Photo ID# 41, Upstream**

**WBID #** 1314      **Site #** 2  
**Mark #** 50      **Dissolved Oxygen (ppm)** 5.5  
**Upstream Views Physical Dimensions:** Is there any water present at this view? y  
 If so, is there an obvious current? n

% of Channel Feature				
Riffle					
Run	100				
Pool

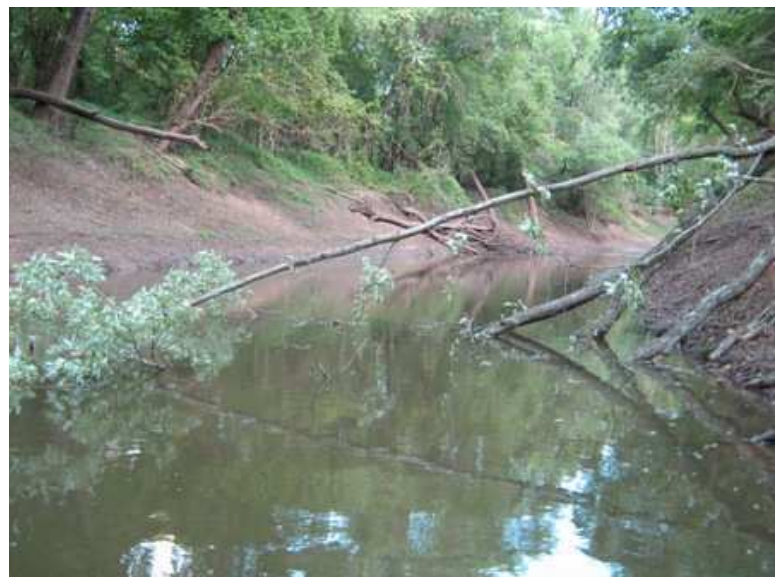
**Site# 2 Photo ID# 40, Downstream**

**Downstream View's Physical Dimensions:** Is there any water present at this view? y  
 If so, is there an obvious current? n

% Cobble	% Gravel	% Sand	100% Silt
% Mud/Clay	% Bedrock

Odor	Sewage	Musky	Chemical	<u><b>None</b></u>	Other
Color	Clear	Green	Gray	<u><b>Milky</b></u>	<u><b>Other</b></u> <u><b>brown</b></u>
Bottom Deposit	Sludge	Solids	<u><b>Fine Sed.</b></u>	None	Other
Surface Deposit	Oil	Scum	Foam	<u><b>None</b></u>	Other

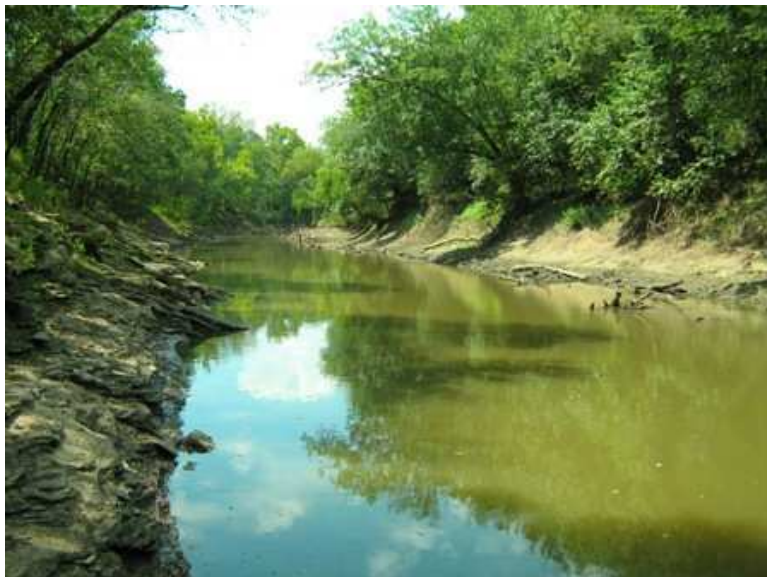
**Site# 3 Photo ID# 43, Upstream**

**WBID #** 1314      **Site #** 3  
**Mark #** 59      **Dissolved Oxygen (ppm)** 5.7  
**Upstream Views Physical Dimensions:** Is there any water present at this view? y  
 If so, is there an obvious current? n

% of Channel Feature				
Riffle					
Run	100				
Pool

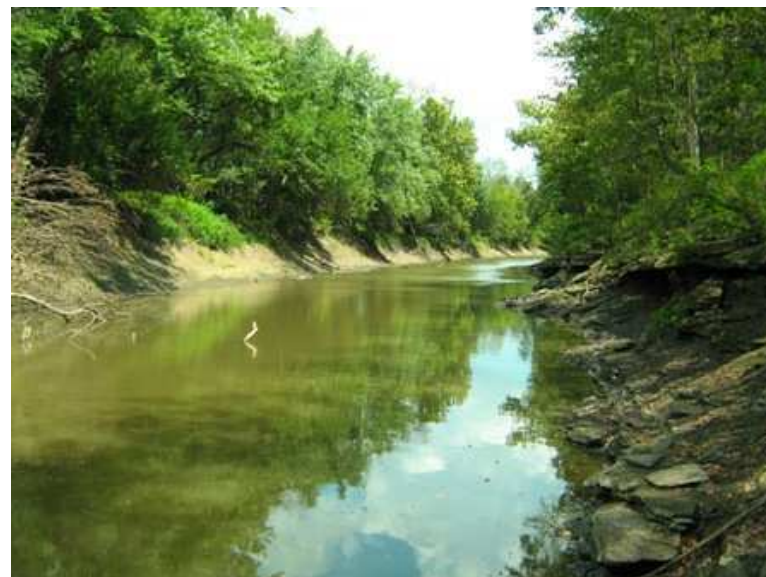
**Site# 3 Photo ID# 42, Downstream**

**Downstream View's Physical Dimensions:** Is there any water present at this view? y  
 If so, is there an obvious current? n

% Cobble	% Gravel	% Sand	100% Silt
% Mud/Clay	% Bedrock

Odor	Sewage	Musky	Chemical	<u><b>None</b></u>	Other
Color	Clear	Green	Gray	<u><b>Milky</b></u>	<u><b>Other</b></u> <u><b>Brown</b></u>
Bottom Deposit	Sludge	Solids	<u><b>Fine Sed.</b></u>	None	Other
Surface Deposit	Oil	Scum	Foam	<u><b>None</b></u>	Other
